SUBJECT : RE-OPENING OF RDMIC BUILDING ER PONCE HALL FOR USE

SITE INSPECTION REPORT

SUBJECT: REQUEST FOR INSPECTION OF DEPARTMENT OF AGRICULTURE - BUREAU OF AGRICULTURAL RESEARCH BUILDING AT BARANGAY DILIMAN, DISTRICT IV, QUEZON CITY

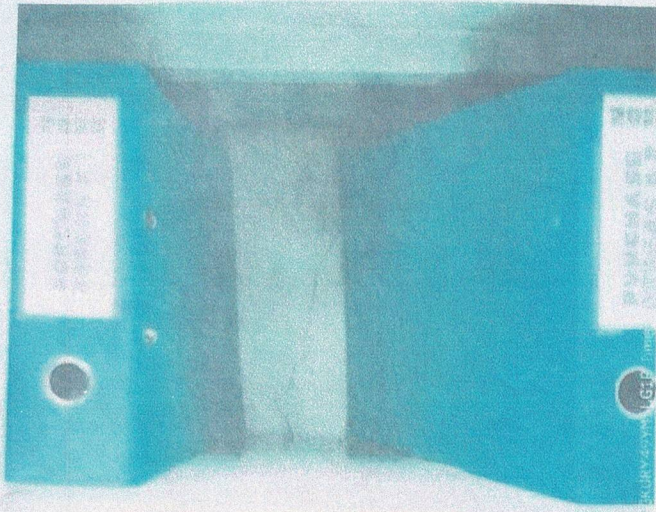
HAIRLINE CRACKS ON THE WALL

It is hereby recommended prompt action for immediate repair of Department of Agriculture – Bureau of Agricultural Research Buildings to fix the deterioration and restore its functionality located at Barangay Diliman.

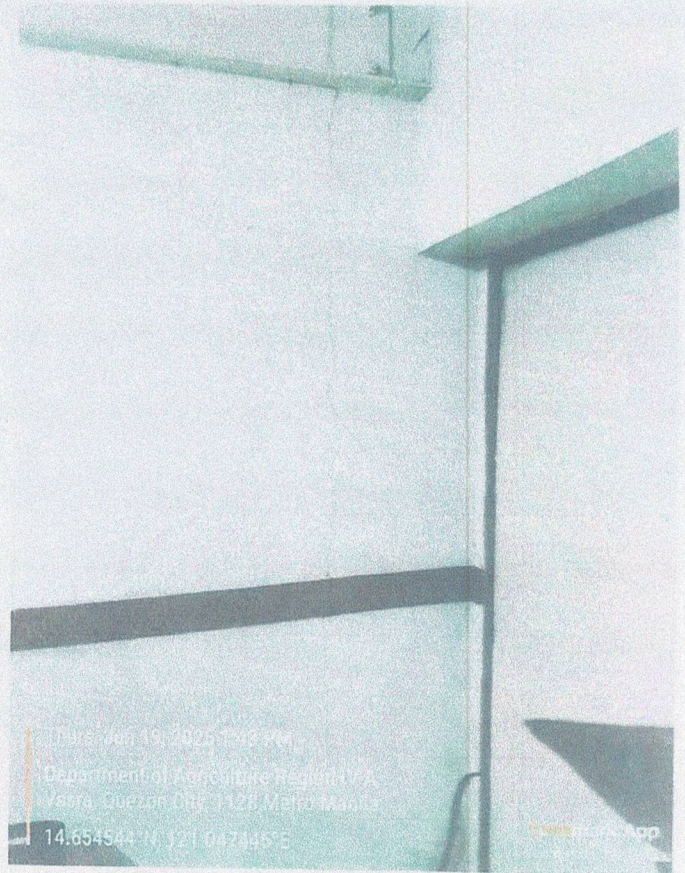
HAIRLINE CRACKS ON THE WALL

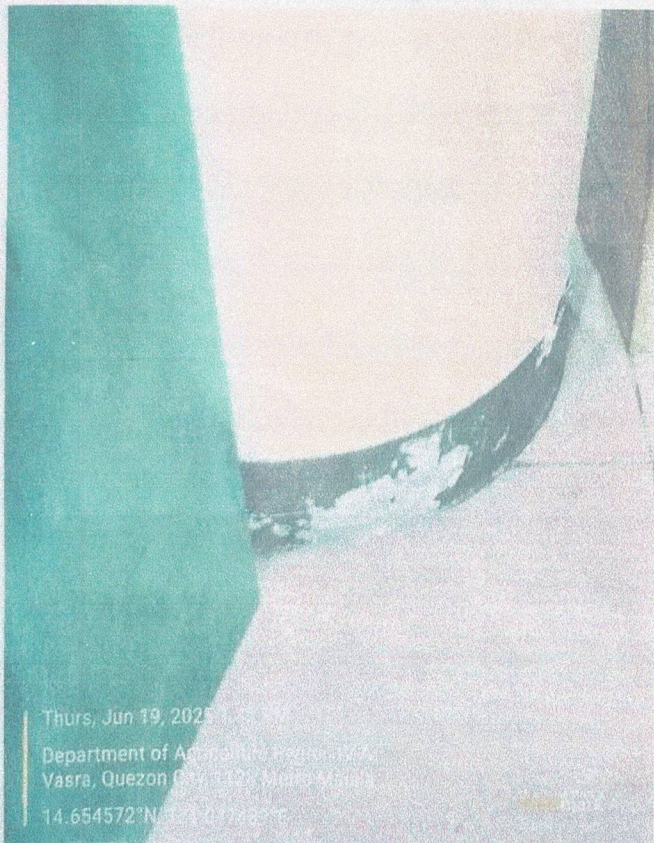
CRACKED PLASTERING OF THE COLUMN

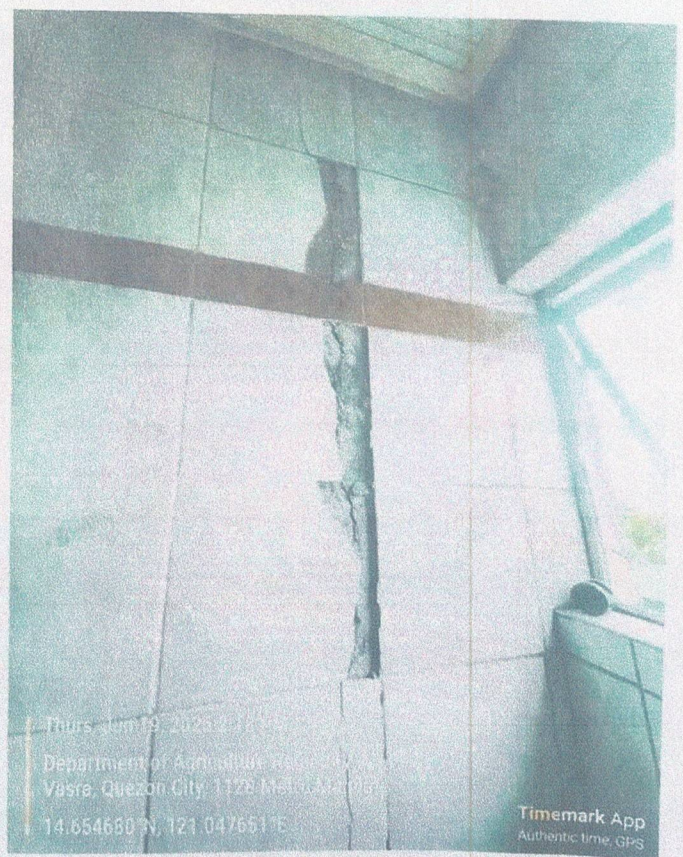
DILAPIDATED TILES
